HOMEBASE INSPECTIONS

4321 Mock Rd
Mock, TX 54321

PROPERTY INSPECTION REPORT FORM

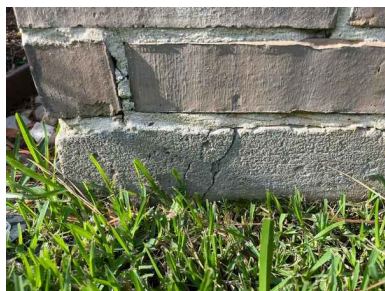
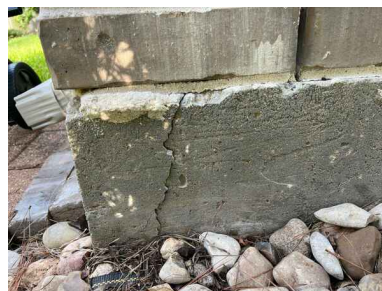
1: Foundation Cracks - Minor

Corner cracks in foundations are not a structural issue. However, corner cracks are an entry point for wood destroying insects and other pests. It's recommended that the cracks be sealed.

Recommendation: Contact a qualified professional.

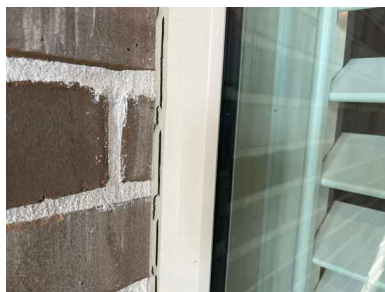
Rear Window

Minor cracking was observed where separation / deterioration of caulking and sealant has occurred, presenting risk for moisture and pest intrusion. It's recommended that a qualified professional assess and repair.

Recommendation: Recommended DIY Project

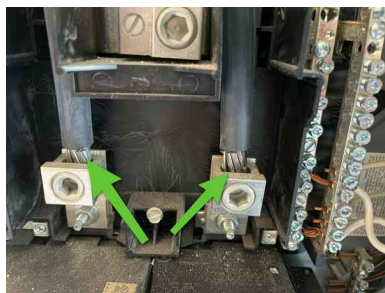
1: Anti-Oxidant Paste Missing

In order to prevent oxidation of the aluminum electric service line connection at the electric panel service box (which could lead to loose connections in the future), it's recommended that a licensed electrician completely cover the connections points with the anti oxidant paste to the point where the above mentioned oxidation cannot occur.

Recommendation: Contact a qualified electrical contractor.

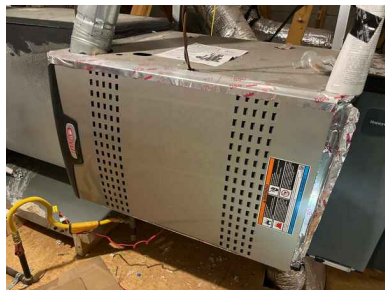
Access Panel is Taped :

The access panel to the attic furnace was taped shut at time of inspection. The inspector does not remove tape or sealants of any kind. The panel could not be removed and condition of components inside unit could not be assessed.

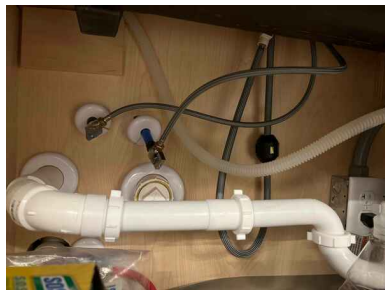
Kitchen Sink Plumbing

The inspector assessed visible and accessible drain, waste, and vent pipes for proper drainage, leaks, and other possible defects. All components seen appear to be in good condition and function as intended.

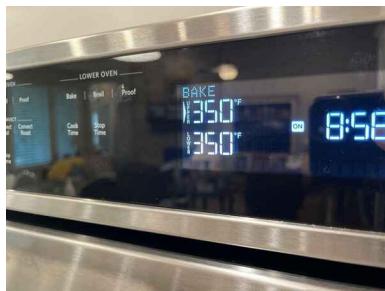
Oven Temperature Display

The oven temperature display showed the top oven had reached the set temperature of 350 degrees, but actual temperature measured was approximately 325 degrees. It's recommended that an appliance specialist evaluate the unit for proper assessment and diagnosis.

Recommendation: Contact a qualified appliance repair professional.
